# **Technical note about the monitoring of hydromorphological restoration/management of the Salzach River (Salzburg, Upper Austria/Bavaria, Austria/Germany)**

**BAW-IWB**

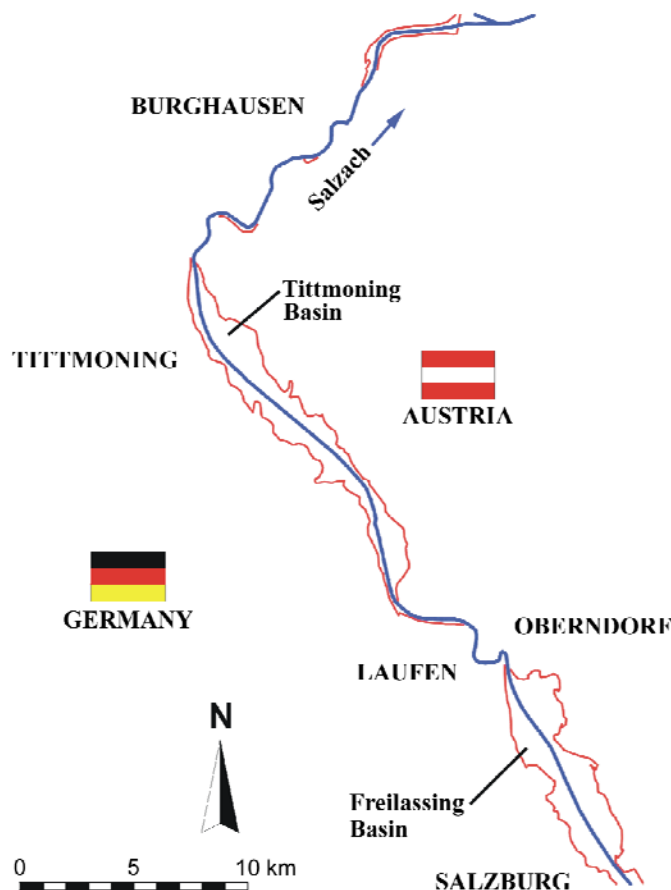
Figure 1: Case Study – Untere Salzach (Lower Salzach)

The concerned river section – called Untere Salzach – begins north of the town Salzburg and reaches from the Saalach river mouth (km 59,3) to the mouth of the Salzach into the Inn. This section is subdivided into 2 basins (Freilassing Basin, Tittmoning Basin) and 2 Narrows (Laufen Narrow, Nonnreit Narrow) (see Figure 1). The bed level difference between km 59,3 and km 12,0 is 46,5 m.

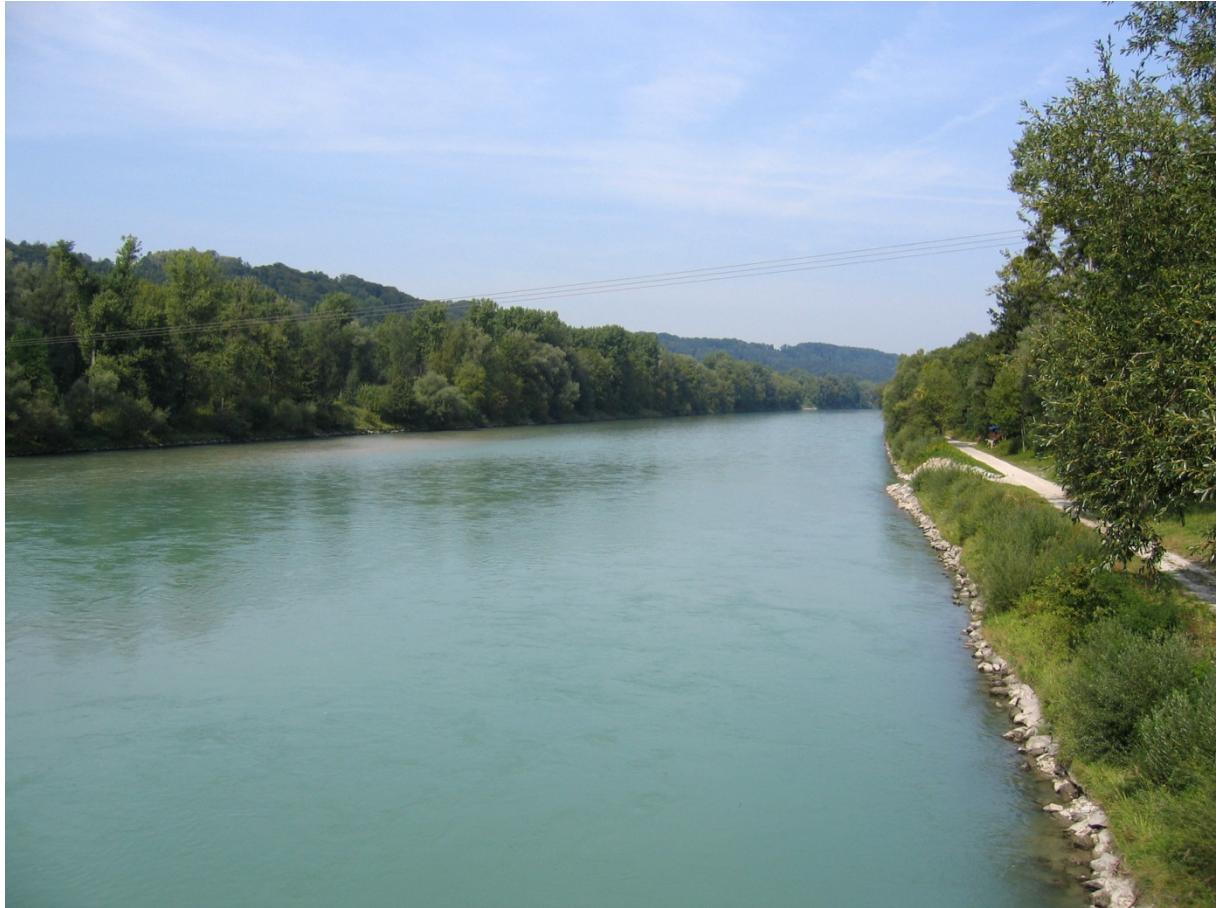
Figure 3: Untere Salzach – a straightened and monotonous river (Stockhammer 2004)

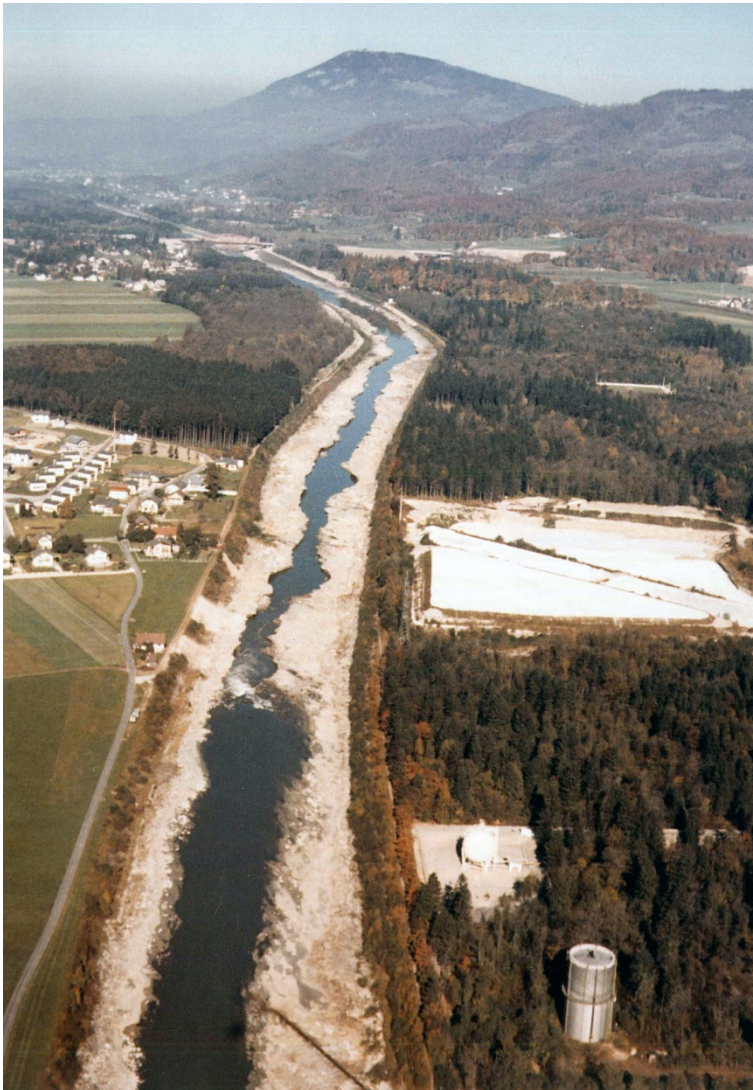
Figure 6: River-bed break-through at the Salzach (Amt der Salzburger Landesregierung 1969)

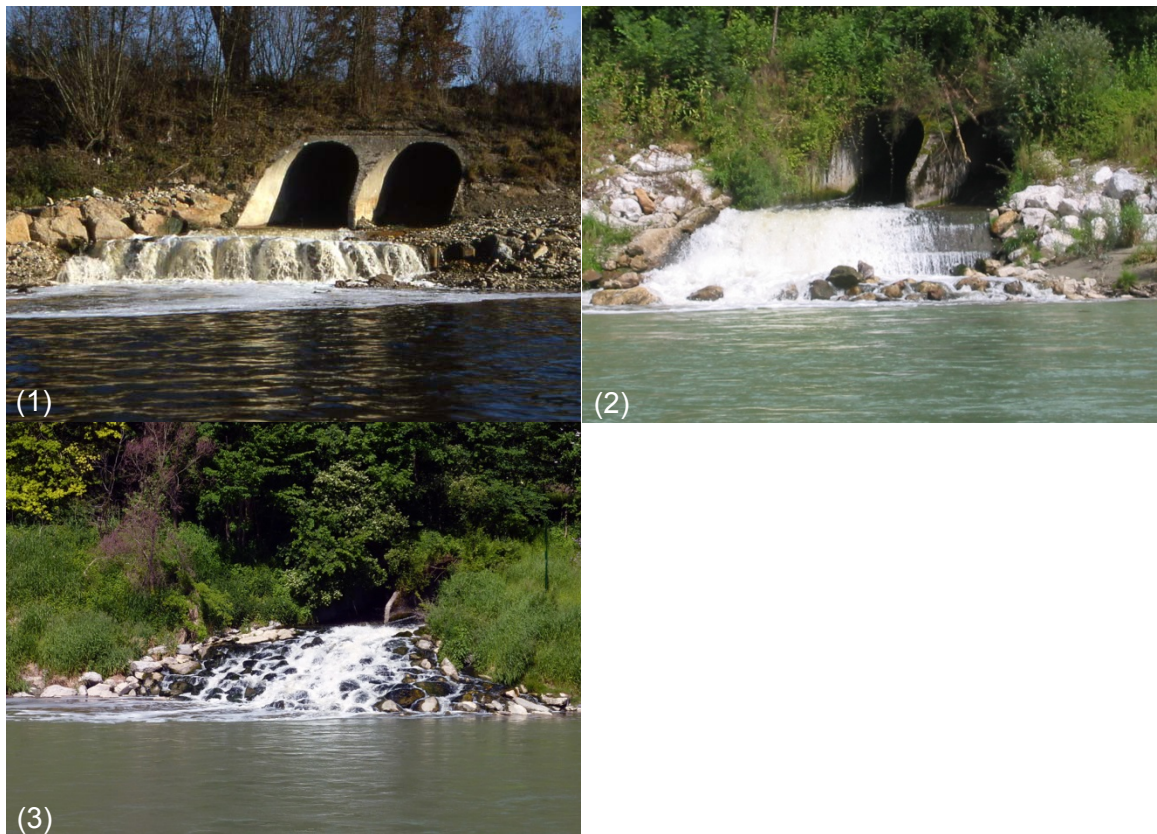
Figure 8: Inlet structure of the water treatment plant Siggerwiesen (km 58,4) Nov. 1986 ( $Q = 90 \text{ m}^3/\text{s}$ ) (1); August 2004 ( $Q = 200 \text{ m}^3/\text{s}$ ) (2); May 2017 ( $Q = 288 \text{ m}^3/\text{s}$ ) (3)

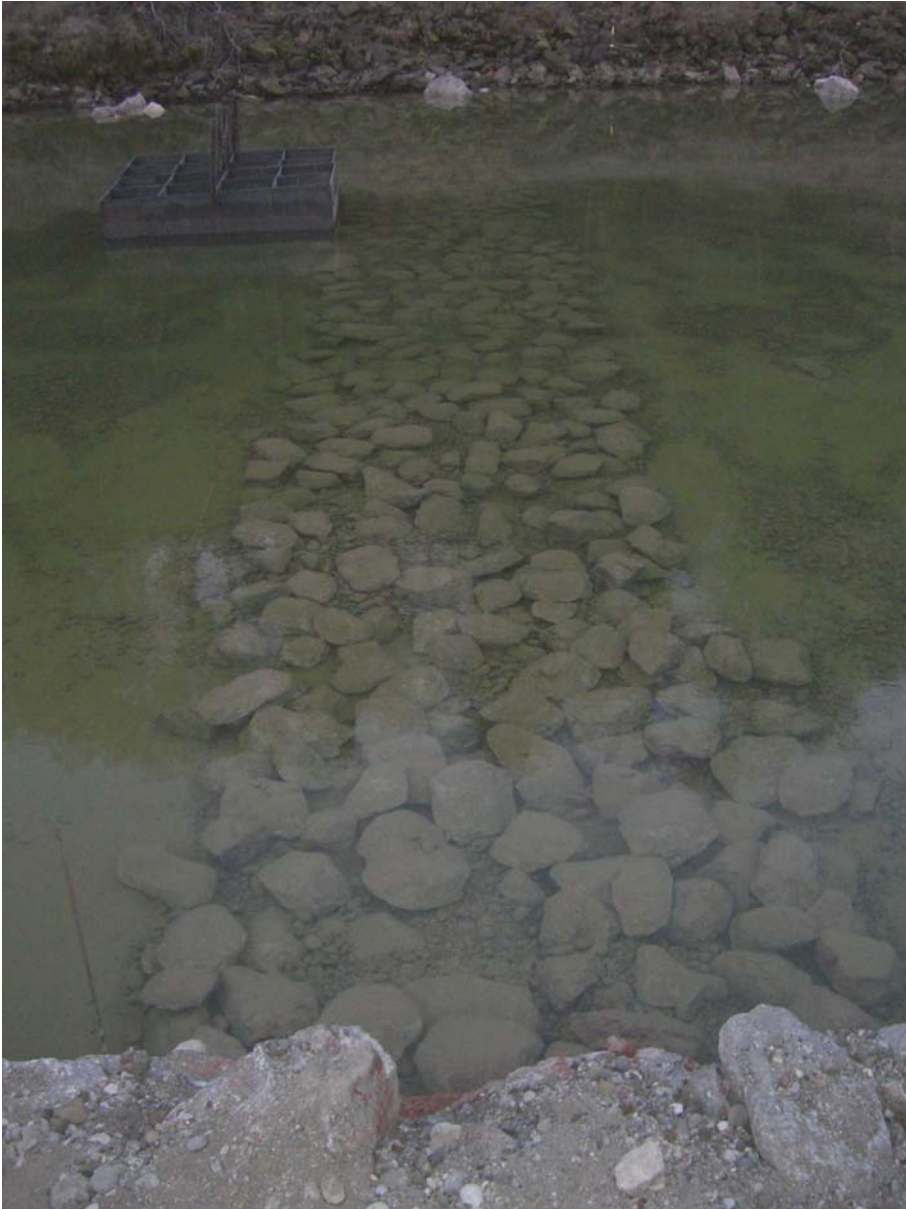
Figure 10: Construction of the rip rap by an evenly spaced stone cover

- 2008-2009 construction of a rip rap-section/revetment (km 46,2) for stabilising the river bed in the Laufener Narrow  
*Design:* The riprap is a stone cover of coarse stones on the river bed with a low cover density leaving a considerable area of the original river bed uncovered by stones. These large stones of the bed cover increase the flow resistance and, thus, reduce both the near-bed flow velocity as well as the erosion of the subjacent bed material.

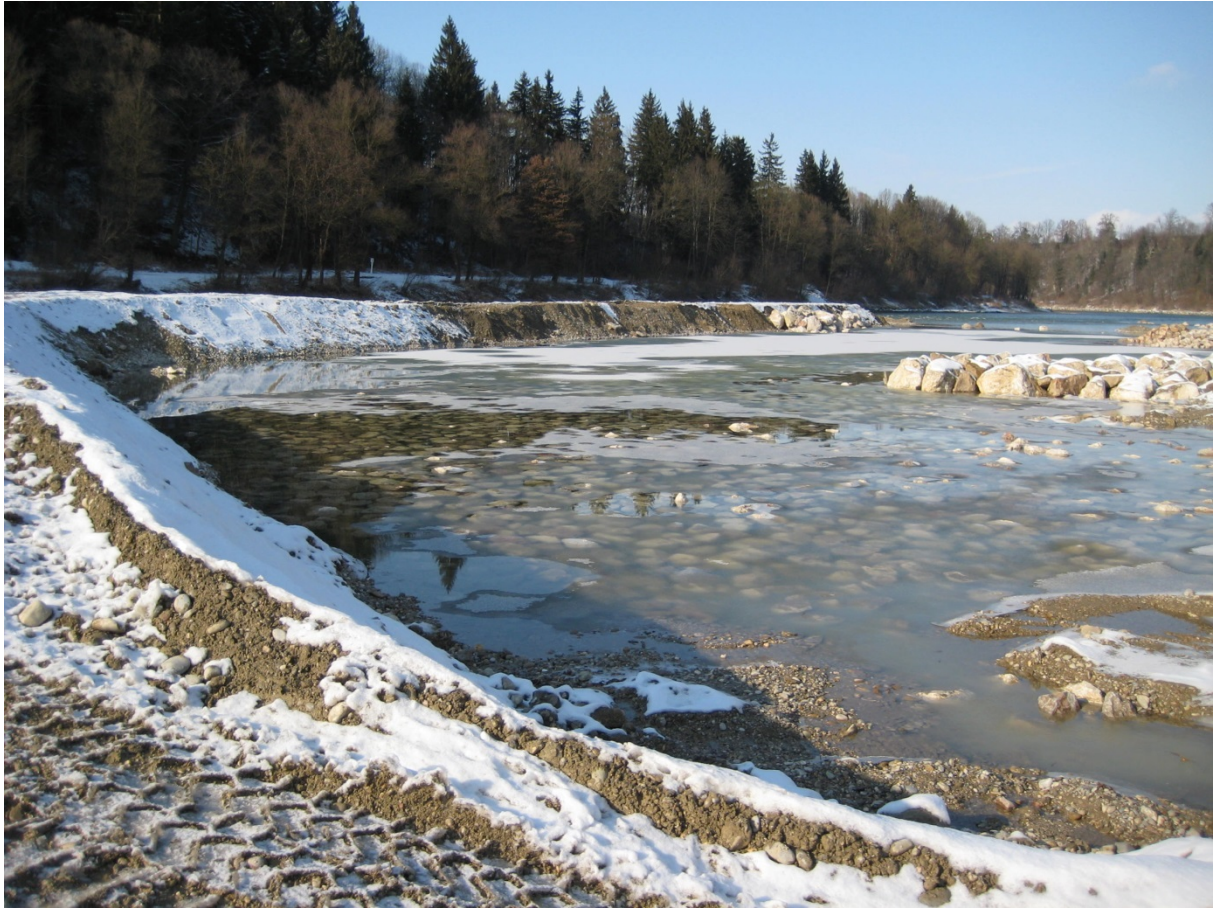
Figure 11: Construction of the rip rap during winter time (low flow period)

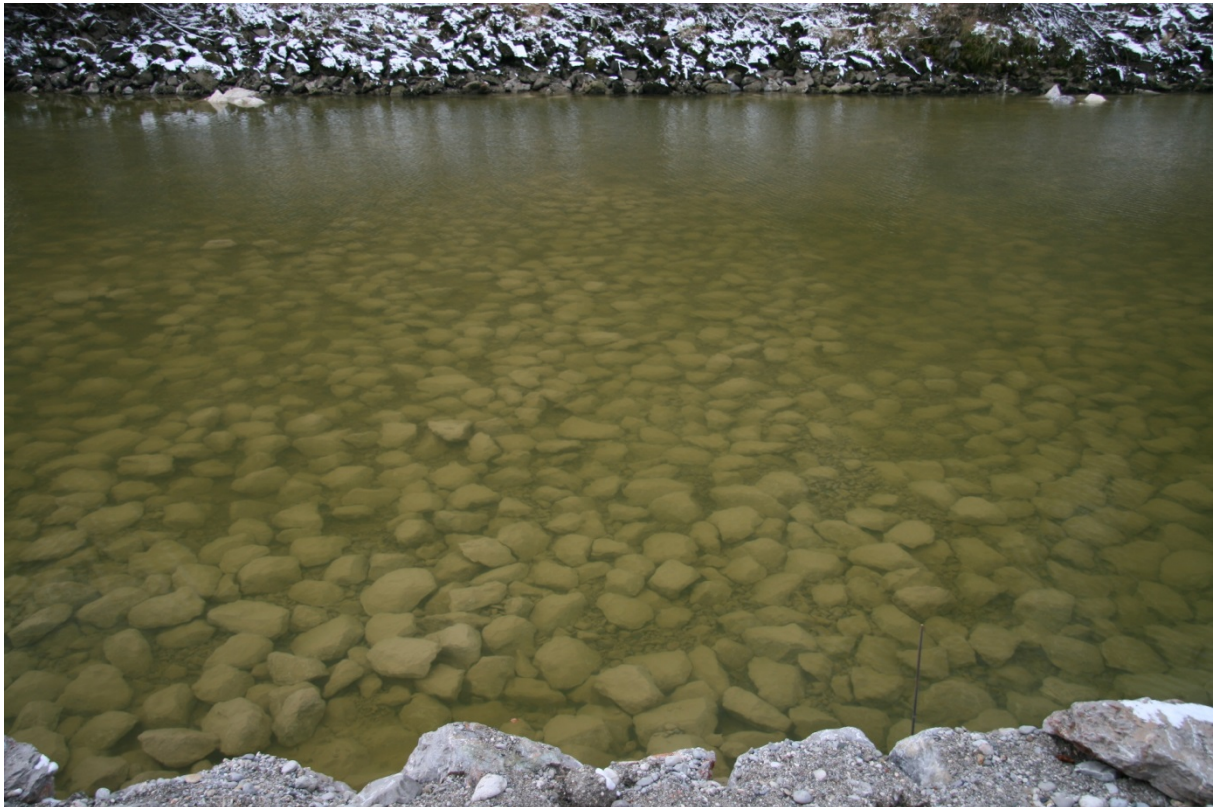
Figure 12: Stone cover of the river bed/rip rap as a bed protection against erosion

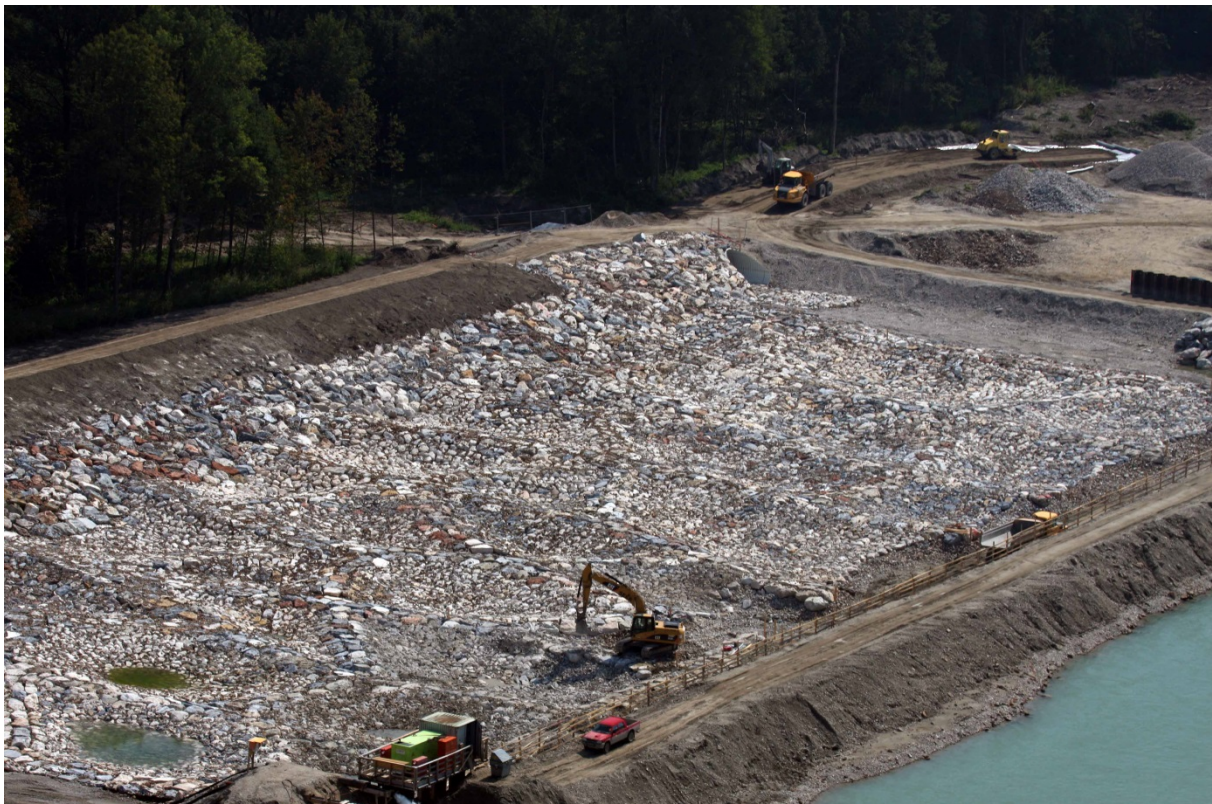
Figure 14: Construction of the step-pool-ramp km 51,9 (Amt der Salzburger Landesregierung 2009)

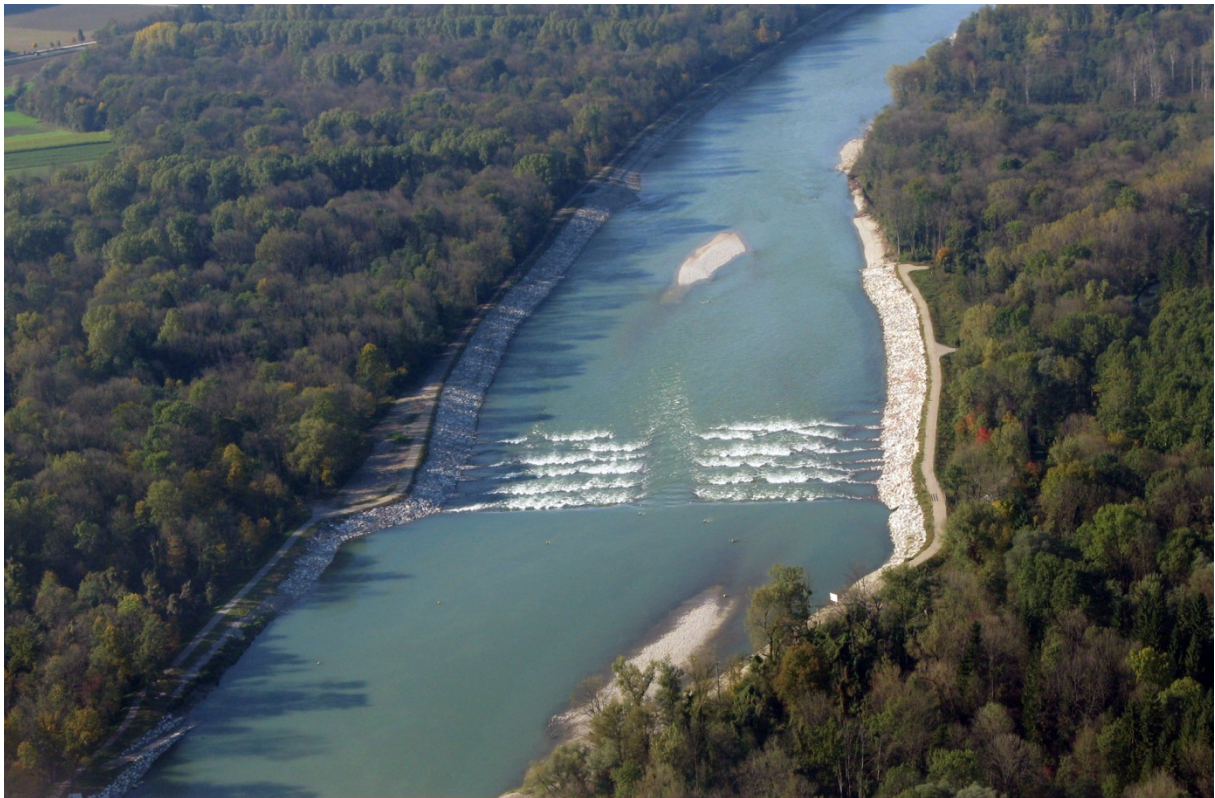
Figure 15: Step-pool-ramp with a boat lane (Amt der Oberösterreichischen Landesregierung 2011)

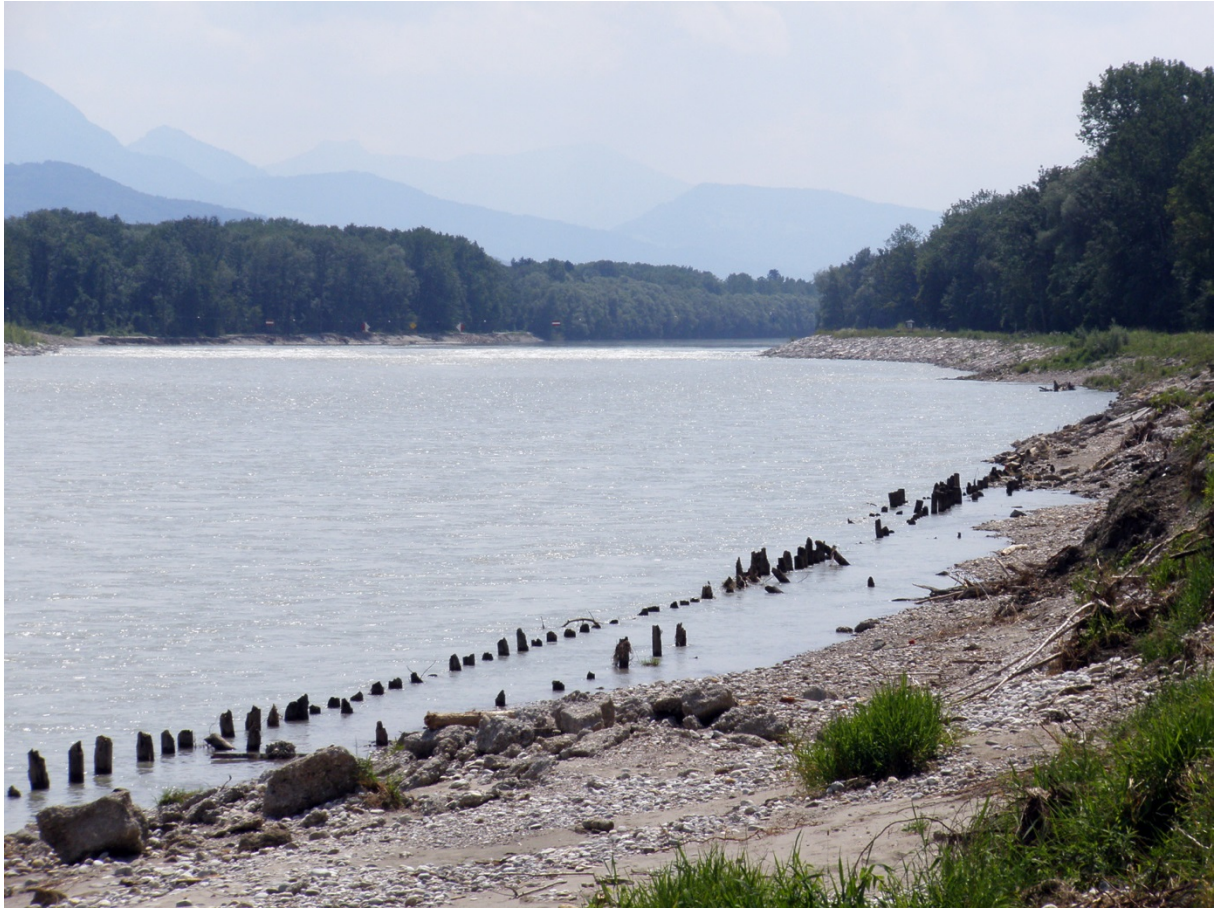
Figure 16: Salzach km 51,9, upstream view, bank erosion and old bank protection

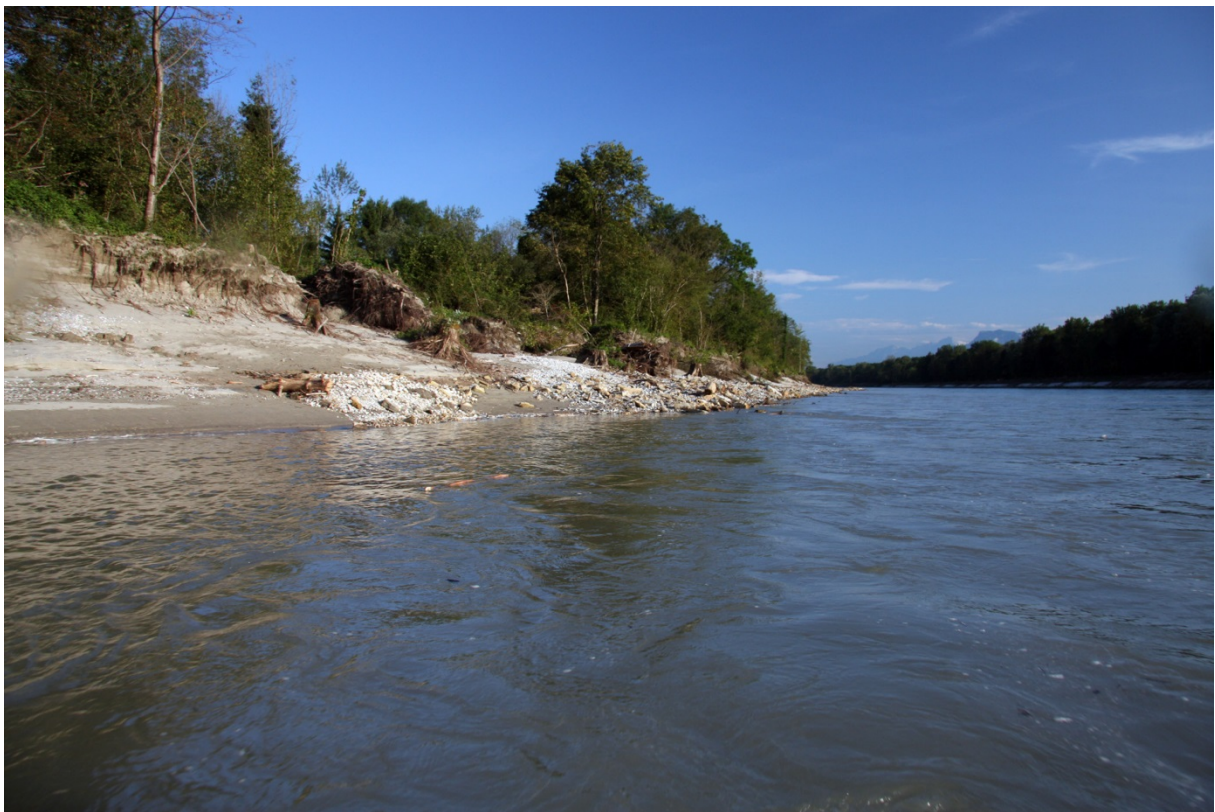
Figure 17: "soft" river banks, Austrian side of the Salzach (Amt der Salzburger Landesregierung 2012)

*Design:* The step-pool-ramp was situated  $13^\circ$  swivelled against the axis of the river to initiate bank erosion by directing the flow towards the river bank. In addition, the bank protection downstream of the ramp was removed to enable bank erosion. These so-called "soft" river banks serve as sediment deposits to meet the bed load transport capacity of the river, since the step-pool-ramp currently operates as a sediment trap for the upstream arriving bed load material. In addition, the conductivity of main river and tributary streams was improved.
