## HyMoCARES Case Study ‘Lech and Wertach Rivers’ (Germany)

**Authors:** *Felix Reeb*s (LfV Bayern), *Mauro Carolli*, *Martin Pusch* (both IGB Berlin)

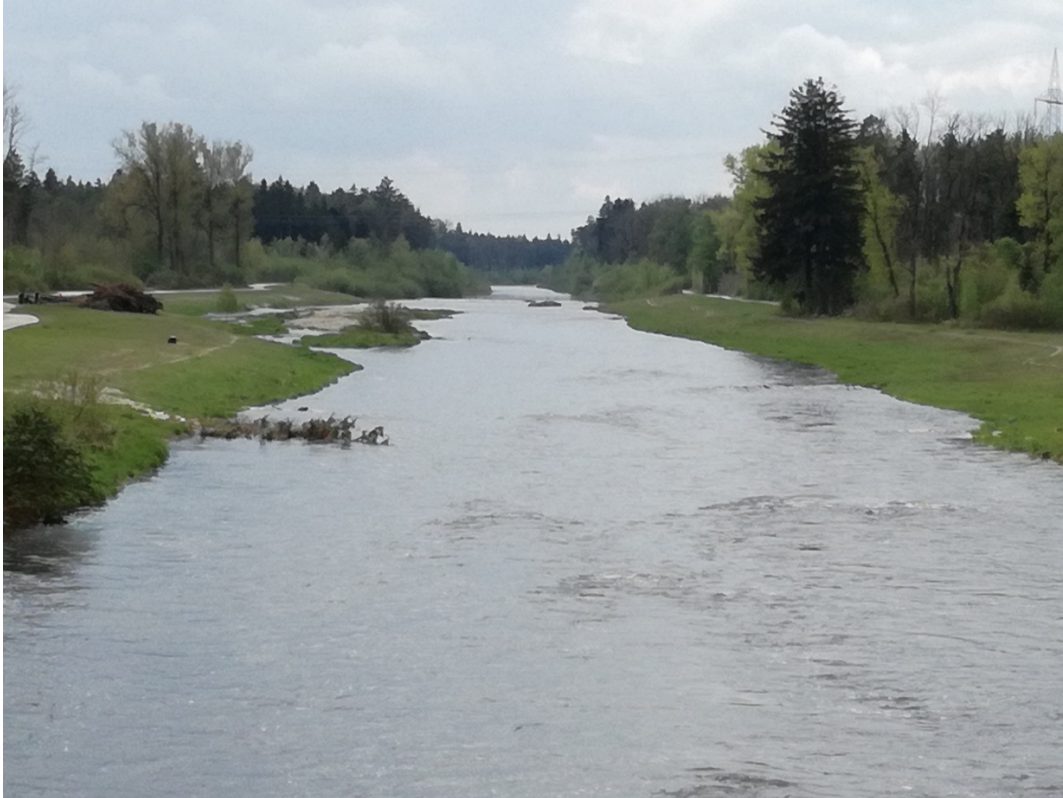
Figure 3: Wertach River restoration site (author: Mauro Carolli, IGB).

Most importantly, the nearby inhabitants of the Wertach river have to be reliably secured from destructive floods. To prevent the river from further erosion, measures have to be taken to reduce shear stress. Construction of a dynamic and continuous river system will help generating a continuous habitat for aquatic fauna and flora.

The „Wertachauen“, as an urban recreation area, will be re-designed in a more natural way, and be accessible for everyone.

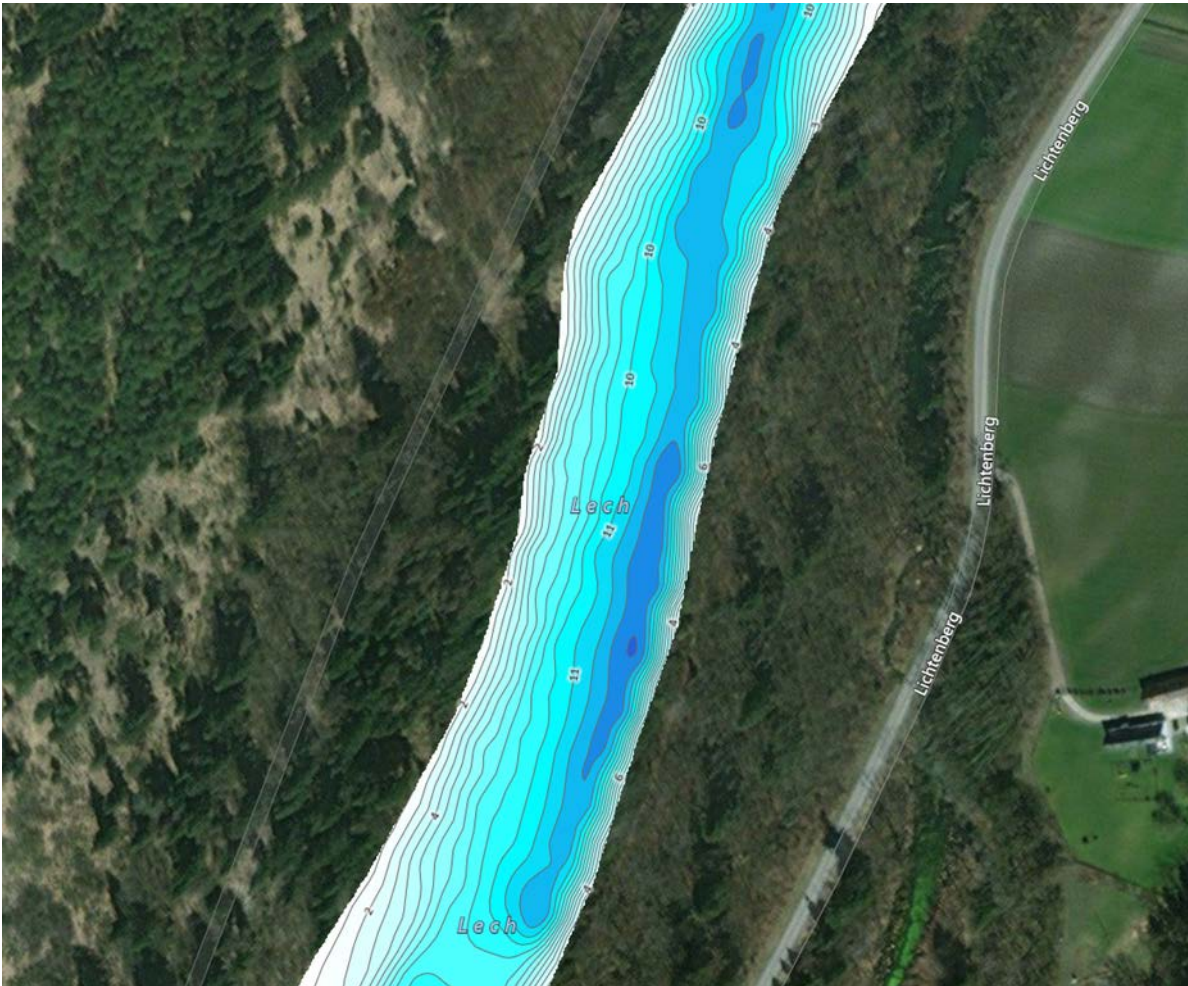
Figure 4: Depth chart (in ft) of the Lech river, near Scheuring, made from echobathymetrics on 21<sup>st</sup> of November before the sediment introduction

The objective of the monitoring with the echo sounding is to assess habitat variations before/after the restoration project. Echo sounding allows to map the river bathymetry and its variations, which could be used as an input for other tools selected and developed in HyMoCARES.

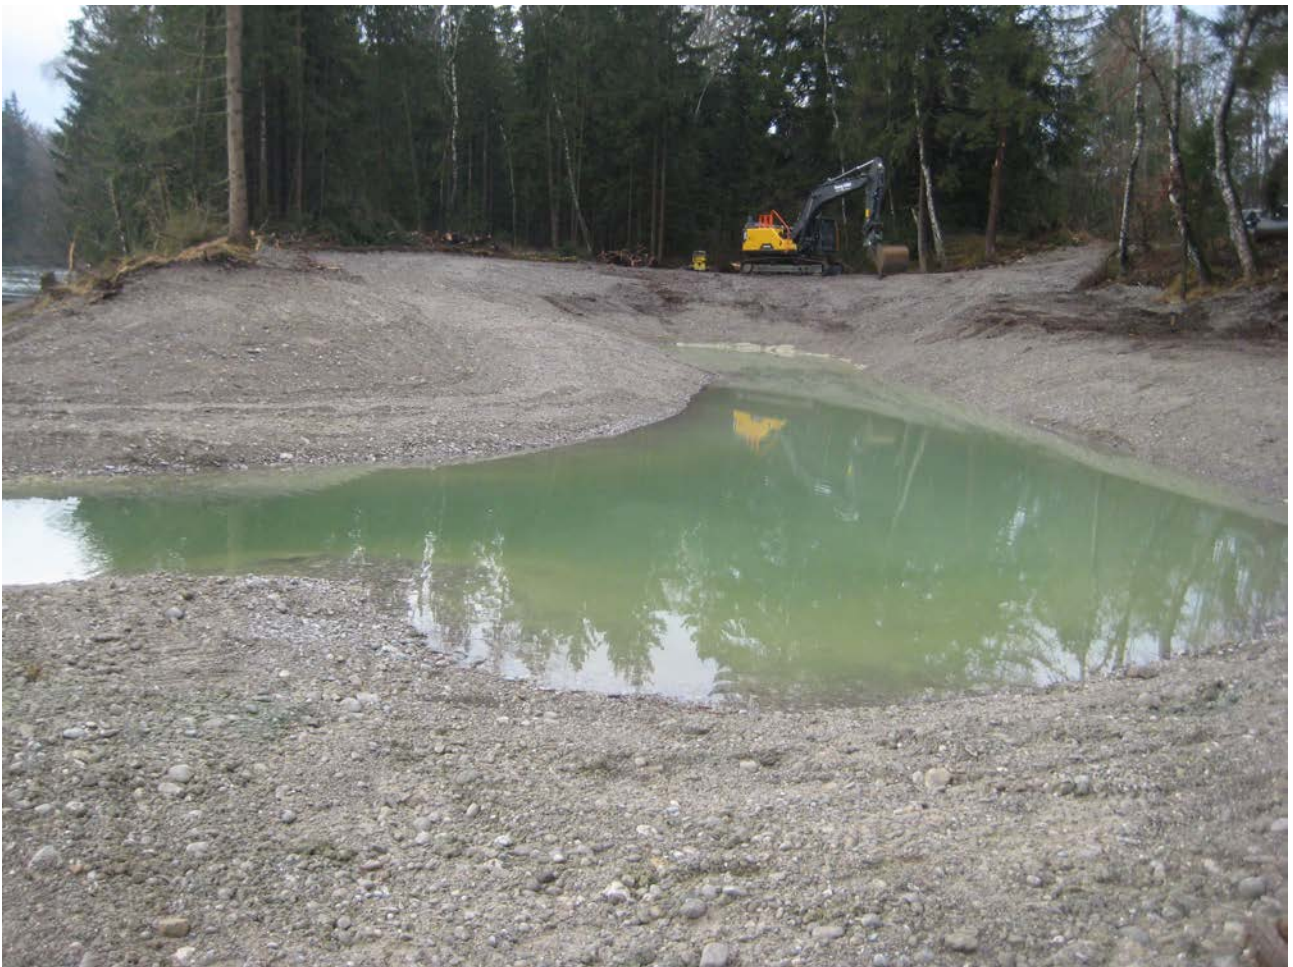
Figure 5: Artificial oxbow near Scheuring on November 30th the introduction of logwood debris and roots will be made soon.

The construction works on the Lech river barrage 20 started on November 21<sup>st</sup> and took until November 30<sup>th</sup>. Figure 5 shows nicely the new created oxbow and the amount of excavated sediments that were introduced into the Lech river. This measure is meant to create key habitats for several lifestages of rheophilic fishspecies of the Lech river in this reach. The missing linkage between spawning grounds and follower habitats and structures is one major component that led to the decrease in biodiversity in alpine streams and that has to be restored.
