Technical note about the monitoring of hydromorphological restoration/management of the Talvera River in Italy

Project: HyMoCARES

Deliverable: D.T3.1.1. - Technical notes on monitoring protocols implemented on river management/restoration pilot sites

Date: 15-03-2019

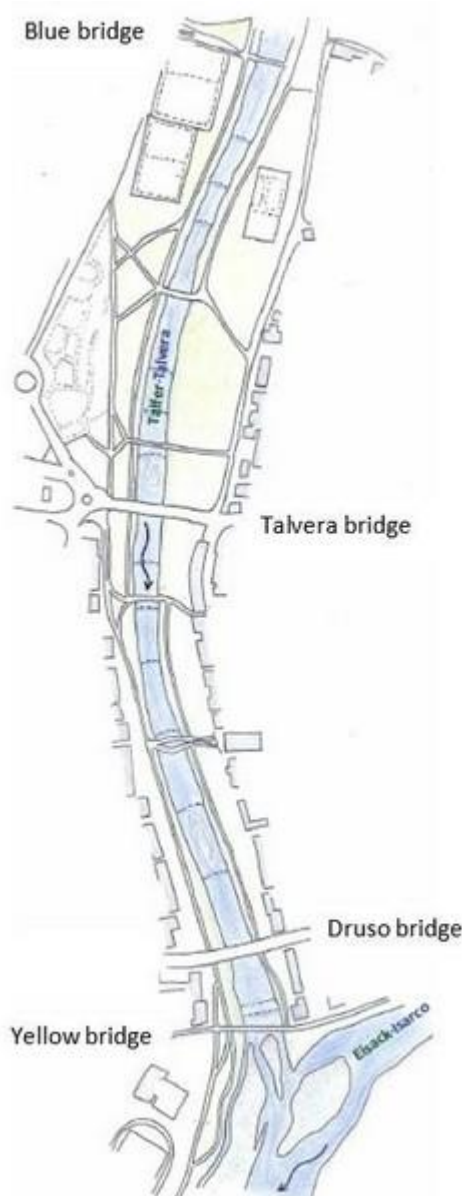
Figure 3 - Planimetric view of the Talvera Torrent before the confluence with the Isarco River

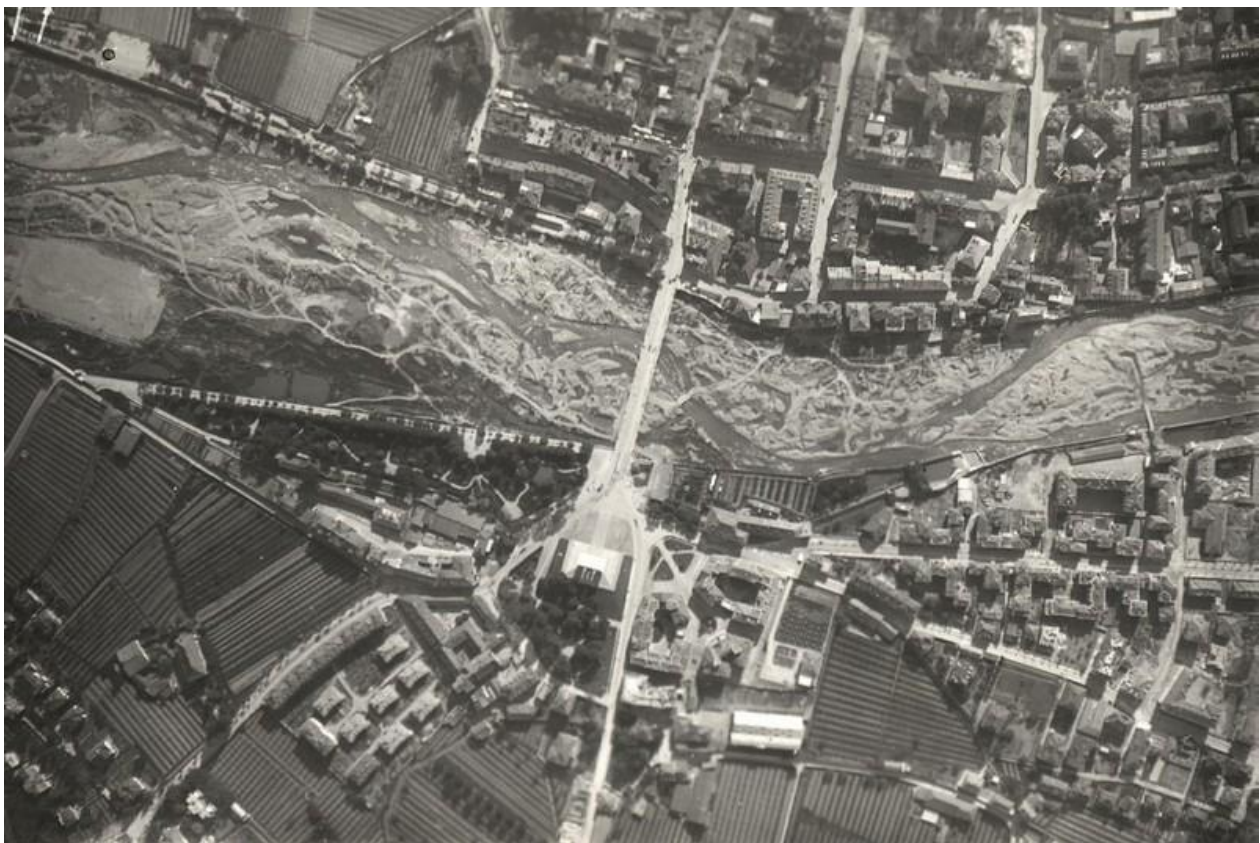
Figure 4 - Aerial image of the Talvera at the Talvera bridge in 1935/1936

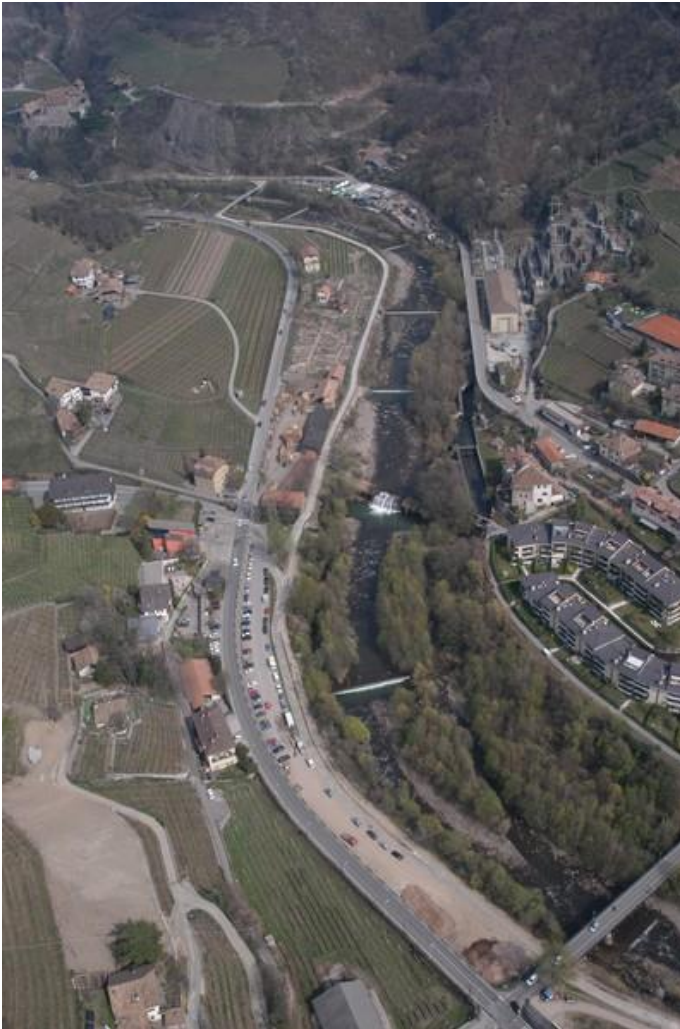
Figure 5 – Upper Talvera river-reach pre-restoration. Series of weirs and a consolidation check dam impeding fish passage. On the orographic left, the S. Antonio hydropower plant.

The reduction of the stream velocity was achieved by building a series of 43 transversal structures whose height ranged between 0.40 m to 6 m (Figure 5). These check dams cut the longitudinal connectivity of aquatic populations along the river reach; as a consequence a loss of habitat occurred, which contributed to a decrease in the number of individuals. Moreover, a selection of fish species occurred according to the check dams height, since some of them are less skilled to jump obstacles: for example, the common barbell (*Barbus barbus*), the European bullhead (*Cottus gobio*) and all the juveniles individuals cannot overcome obstacles higher than 80 cm.

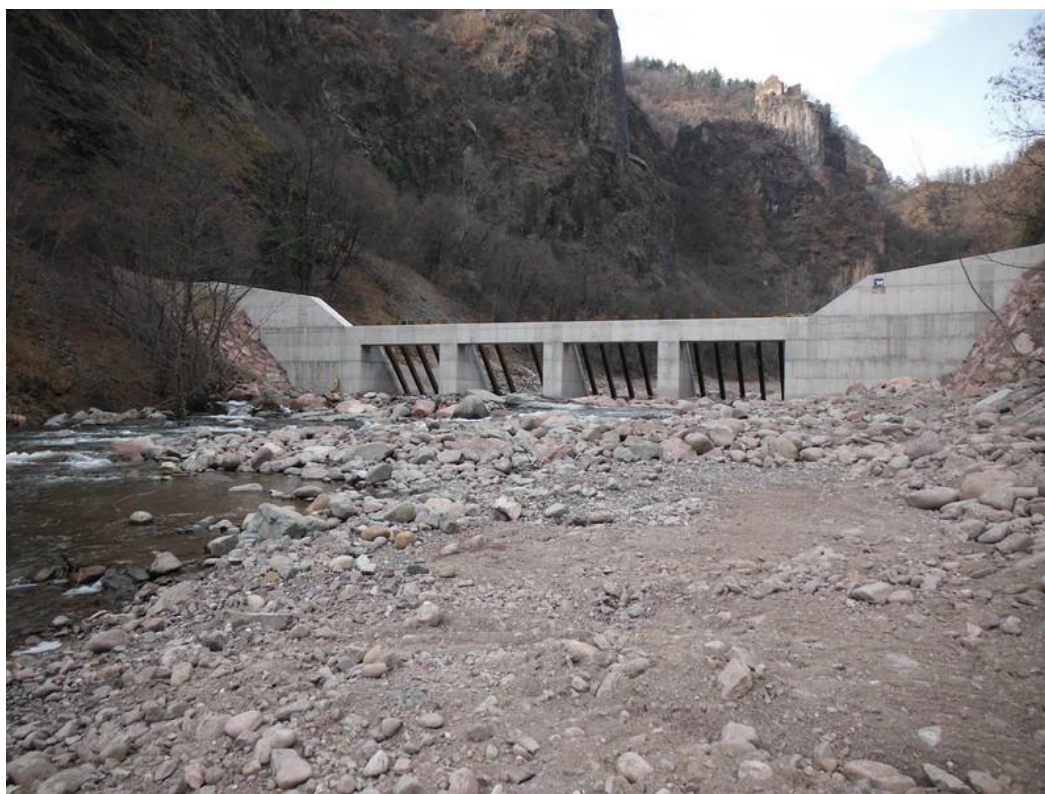
Figure 9 - Retention check dam constructed within the HyMoCARES project, sited 4.1 km upstream from the Isarco confluence. View from downstream to upstream

- Removal of a consolidation check dams in the upper reach, which was substitute with a retention check dam (*Figure 9*), where fish migration is ensured also in low water regime. A retention basin was build upstream guarantying sediment entertainment. Further measures are planned to be deployed during the winter 2018/spring 2019 regarding the demolition of a dam at the Sill ice rink area. The 5 m jump will be retrieved by means of an ascending fish ramp.

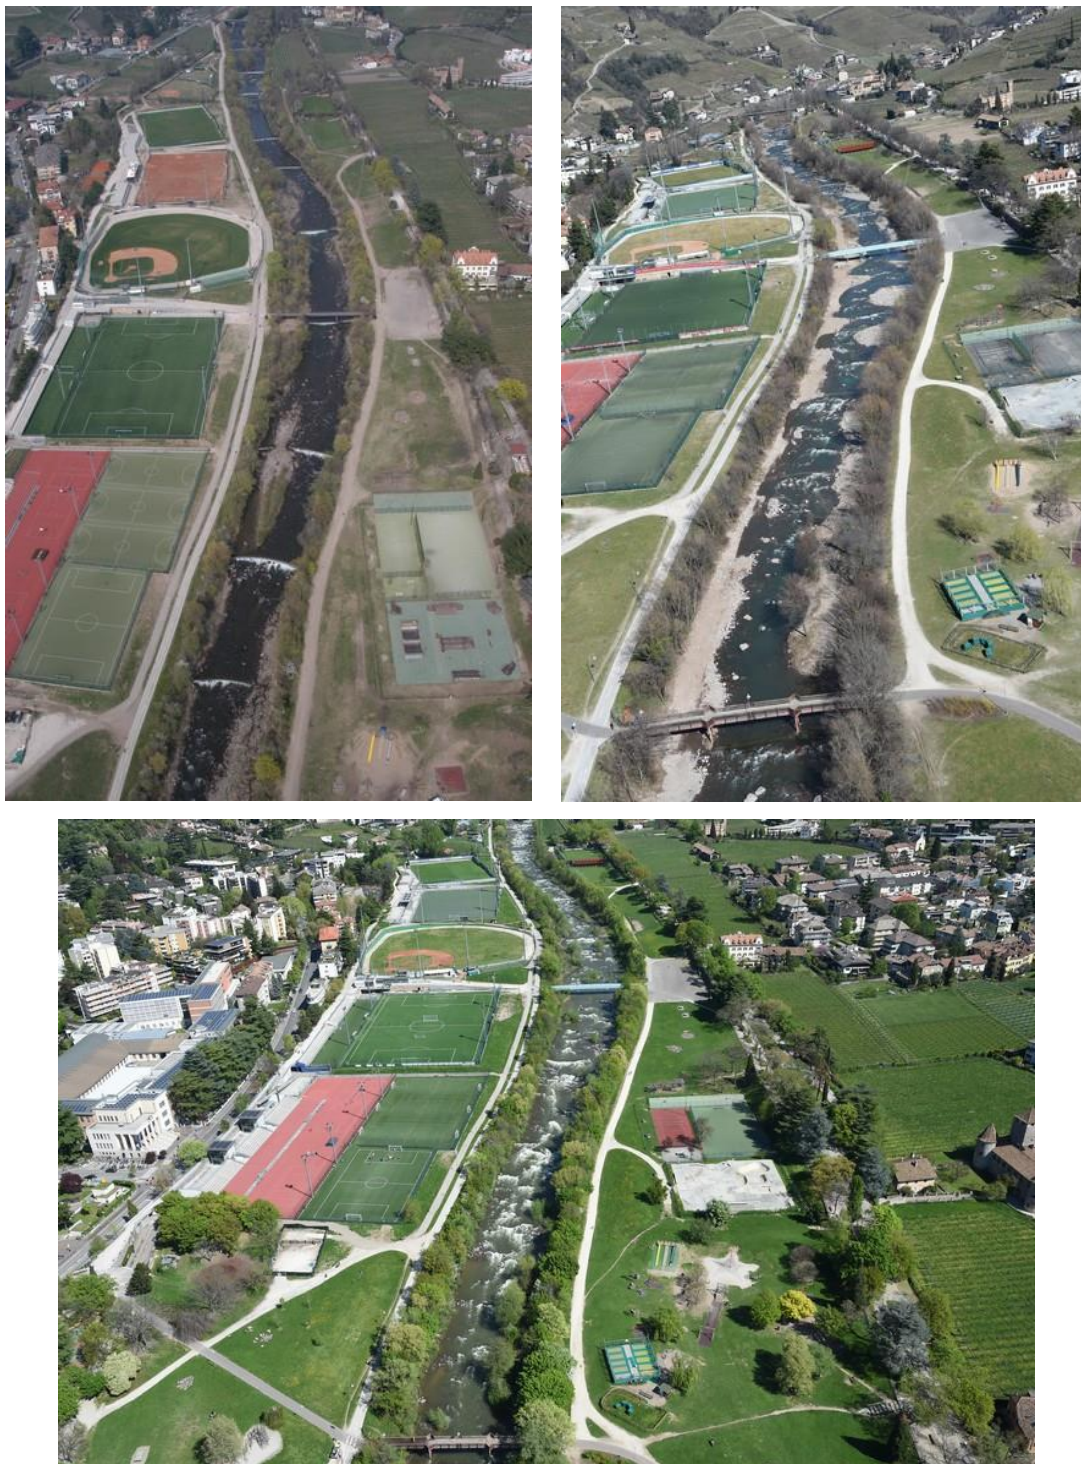
Figure 10 - Talvera River upstream Talvera bridge in 2004 (top-left), 2015 (top-right) and 2018 (bottom)

Figure 10 displays a comparison, for a reach of the Talvera, before restoration measures took place, during the restoration (2015) and at the end.
