Technical note about the monitoring of hydromorphological restoration/management of the Isarco River in Italy

Project: HyMoCARES

Deliverable: D.T3.1.1. - Technical notes on monitoring protocols implemented on river management/restoration pilot sites

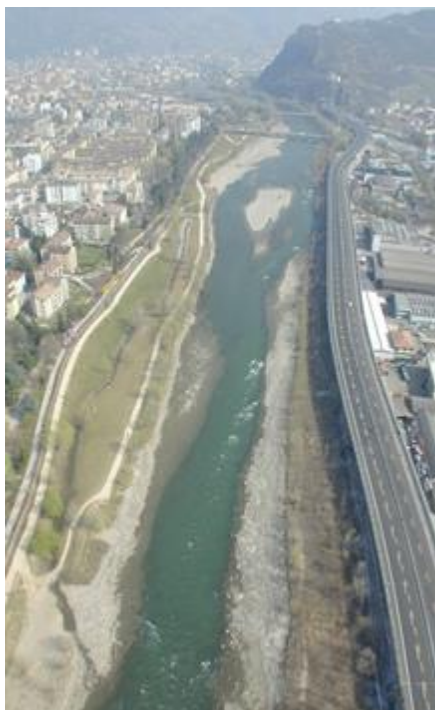
Figure 2: Alternate bar structures of the Isarco River

The river morphology is characterized not only by alternate bars, but also by a forced bar structure caused by the sediment supply provided by the confluence of the Talvera river. The bar mobility is limited due to a scarcity of solid material inputs from the tributaries, and from the Isarco itself. This involves the progressive erosion of the channel bed and marked local incision of the riverbanks (up to 4-5 m), once the bars have

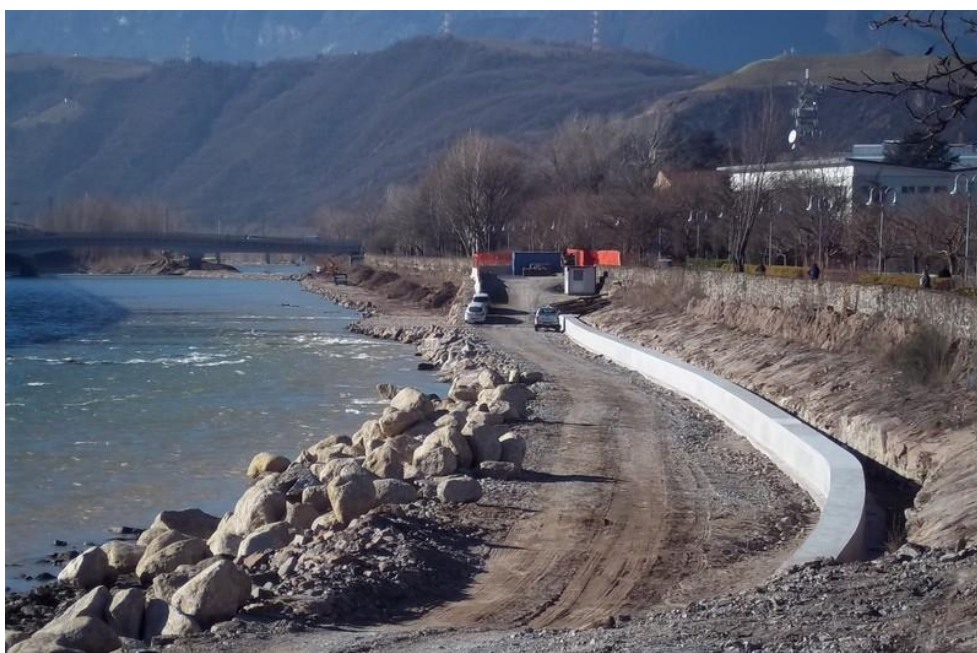
Figure 6 – Bank reinforcement through concrete kerb

- Foot reinforcement of the bank wall. Erosion processes tend to erode the terrain below the wall causing it to collapse. For this reason, the bank wall has been footed with a reinforced concrete kerb on micropiles to ensure wall stability and flood protection.

Figure 4 displays an overview of the main restoration works carried out within the studied river reach. The colors indicate different years of interventions; most of the restoration actions took place along the riverbanks, but also the construction of flow deflectors is clearly visible. *Figure 5* shows an example of a restoration work. The cycling path was slightly diverted to allow the shaping of a recreational area and the access to the river. At the same time, the bank wall has been footed with a reinforced concrete kerb on micropiles to prevent lateral incision (*Figure 6*). An example of flow deflectors is shown in *Figure 7*: they were generally placed perpendicular to the flow and slightly leaning upstream.

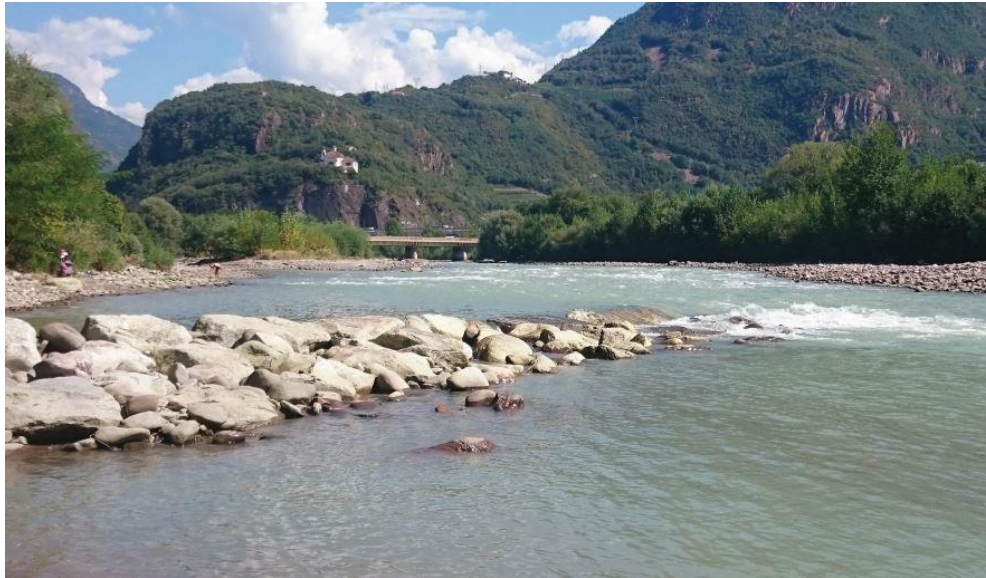
Figure 7 - Example of a flow deflector placed downstream the Roma bridge. View from downstream

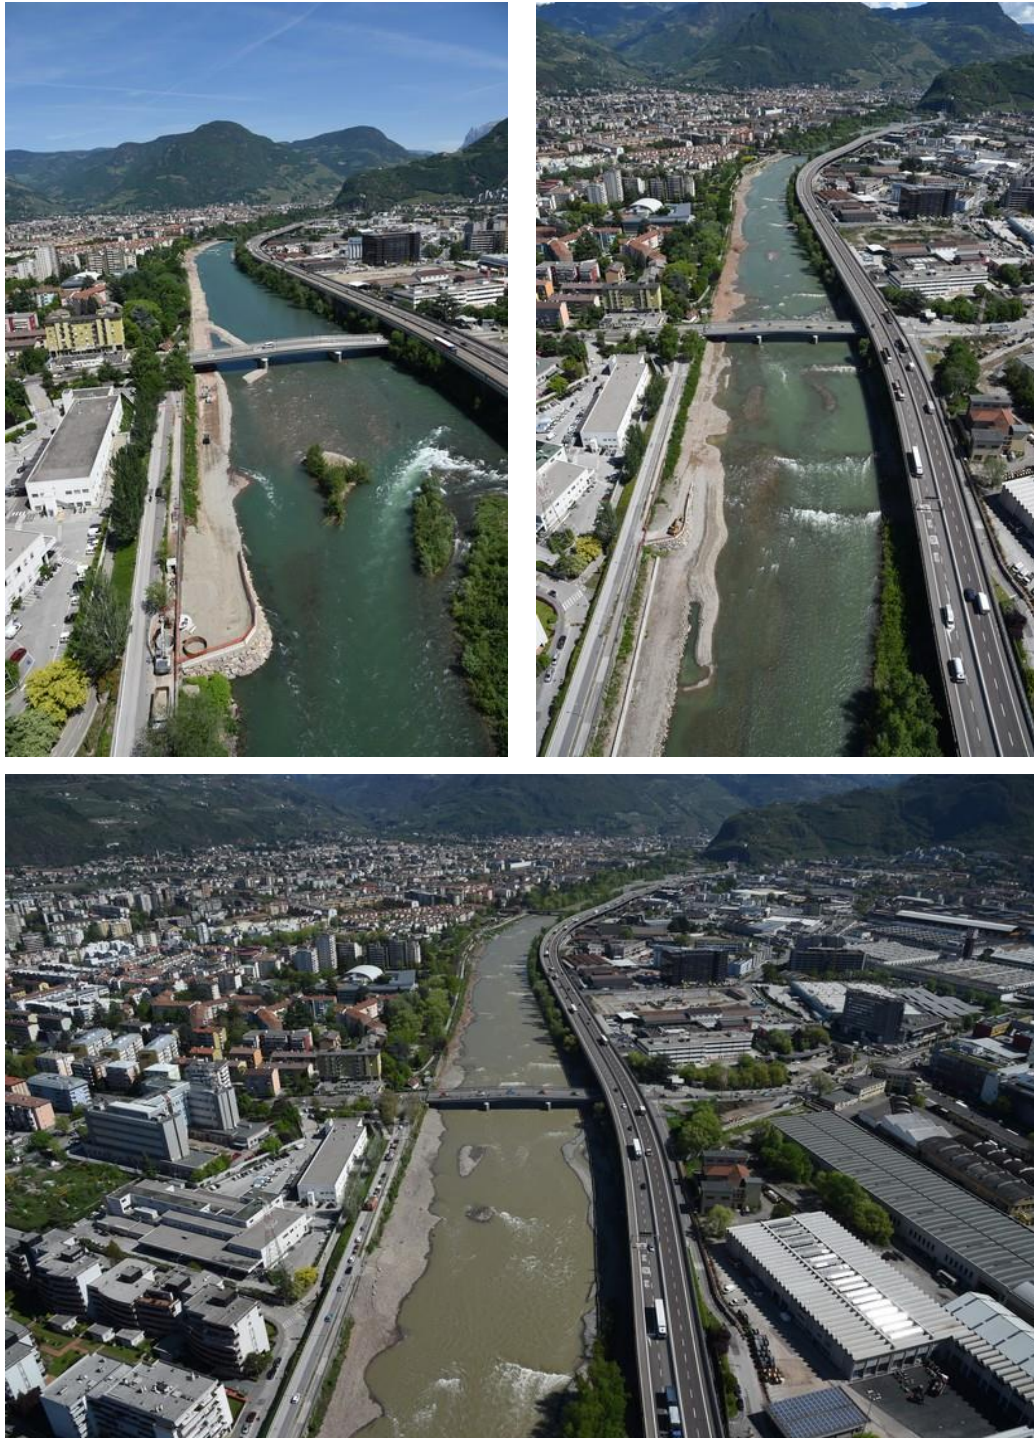
Figure 9 - Isarco River at Resia bridge in 2015 (top-left), 2016 (top-right) and 2018 (bottom). In the most recent pictures flow deflectors are visible as well as riverbanks variability
